BRE Review of March 2022 Revision of Wind Microclimate Reports in Respect of Outline Planning Application 200328 at Vastern Court, Caversham Road, Reading

2. Review of the Technical Appendix 9.1 Wind Microclimate (dated 25th March 2022) prepared by Xi Engineering Consultants Ltd

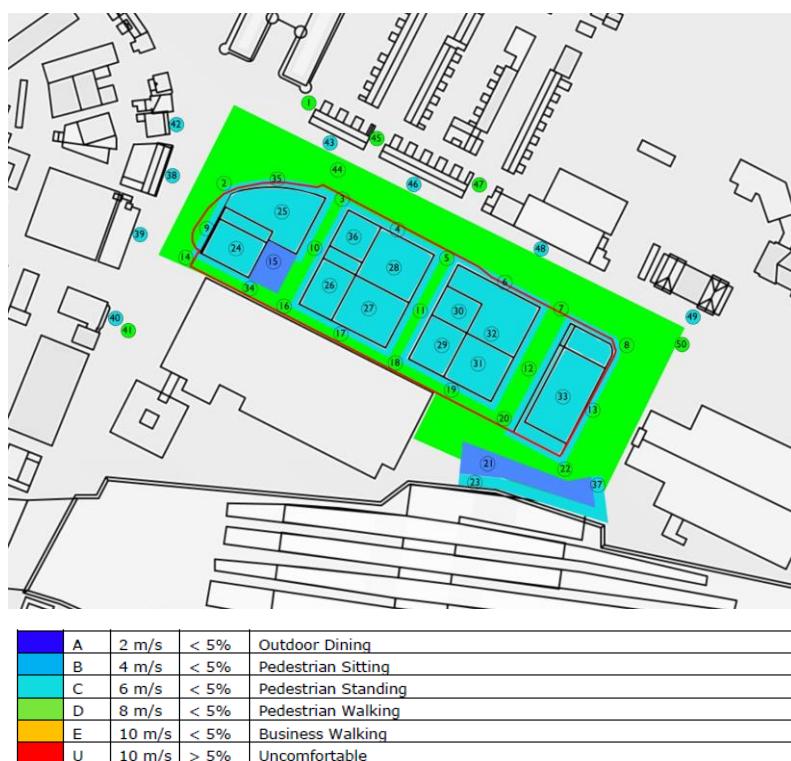
Figure 9.3 Proposed Development Assumed Intended Pedestrian Use

Figure 9.3, included for convenience below, shows an area to the south of the proposed development between measurement locations 21 and 37 and a large area around measurement location 15 which are designated as assumed outdoor dining areas.

There does not appear to be a discussion of the suitability of wind effects in these two areas for outdoor dining. The wind conditions at measurement location 15 are classed as “Uncomfortable”, this is five categories more severe than the target category and would be major adverse (note that major adverse is classed as being three categories worse than the target category – so this is a very severe major adverse condition). The wind conditions in the area between measurement locations 21 and 37 is classed as suitable for “Pedestrian Walking”, again a major adverse condition.

BRE Comment: A discussion of the usage of these two outdoor dining areas and appropriate mitigation must be specifically included
