Russell Street/Castle Hill Conservation Area

Conservation Area Appraisal

March 2020

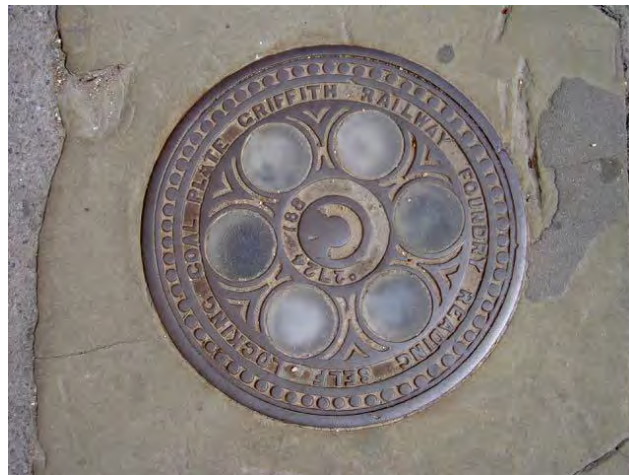
Figure 5.5.4 Coal hole cover, Castle Hill (Evelyn Williams)

Cast iron coal hole covers made originally in Reading's foundries are particularly in evidence on Castle Hill and Prospect Street.

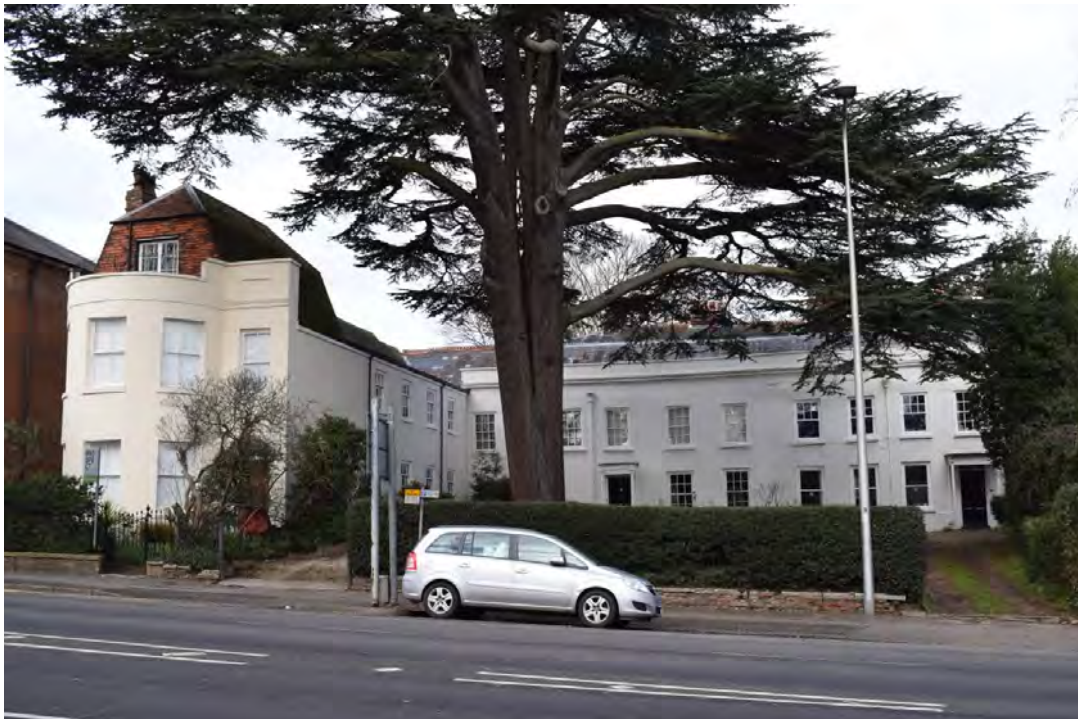
Figure 6.1.4 154- 160 Castle Hill, the former Kings Arms Inn, and Jesse family home (Karen Rowland)

The Grade II* 154-160 Castle Hill, originally the Kings Arms Inn, with its striking Cedar of Lebanon tree in its forecourt, is the street's most notable and impressive building (see figure 6.1.4). Dating from the late 17th century, its long history is detailed in Appendix I. The 18C railings to the street are hidden within holly bushes,

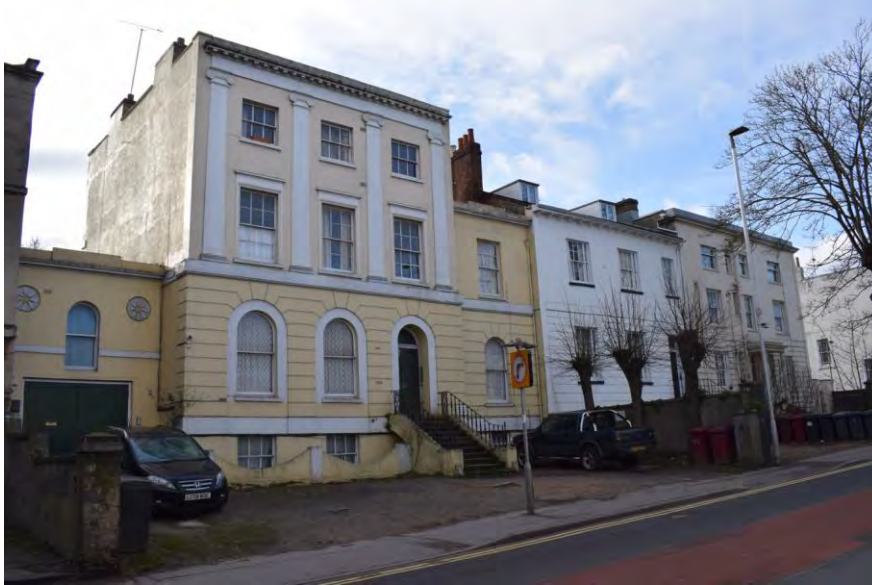
Figure 6.1.10 Large rusticated Georgian houses on the south side of Castle Street at 107-111 (David Neale)

The houses at nos.107-111 and nos.122-132 (all Grade II), define the early building at the east end of the street. These houses are large, often rusticated and stuccoed; many with original arched windows and fanlights. The house at no.107 still retains its stable building and the footprint of its large, original garden to the rear.

- 111 Castle Street (S. side), Grade II. Late 18th-early 19th century house, altered, 3 storeys and semi basement. Stucco, rusticated to ground floor and basement, cornice and parapet. Steps to entrance. Porch with slender fluted Doric columns. 1321960.

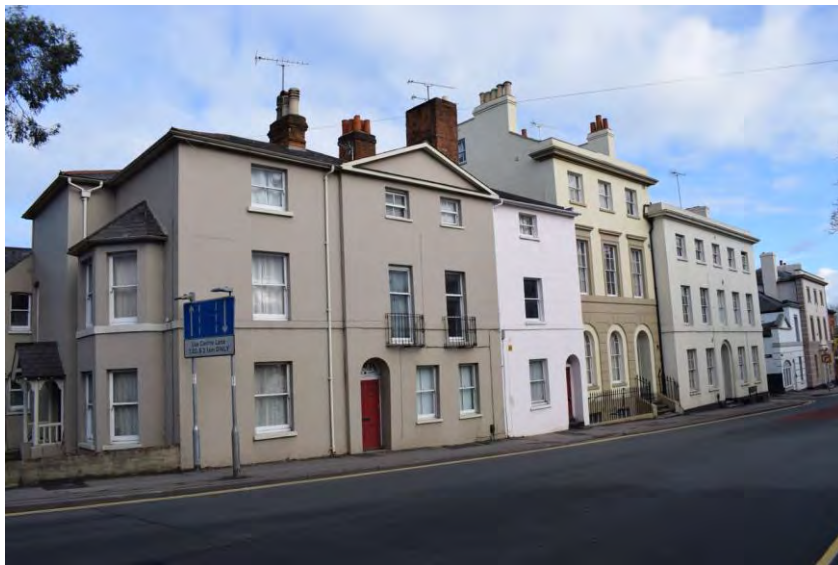
Figure 6.1.11 Large Georgian properties on the north side of Castle Street at 122-132 (David Neale)

- 122 Castle Street, Grade II. Circa 1840, 3 storey stucco house, rusticated ground floor and corner pilasters, raised surrounds to upper windows, cornice, parapet and slate roof. Central entrance door and fanlight, panelled pilasters. 2 storey extension to west. 1154757.

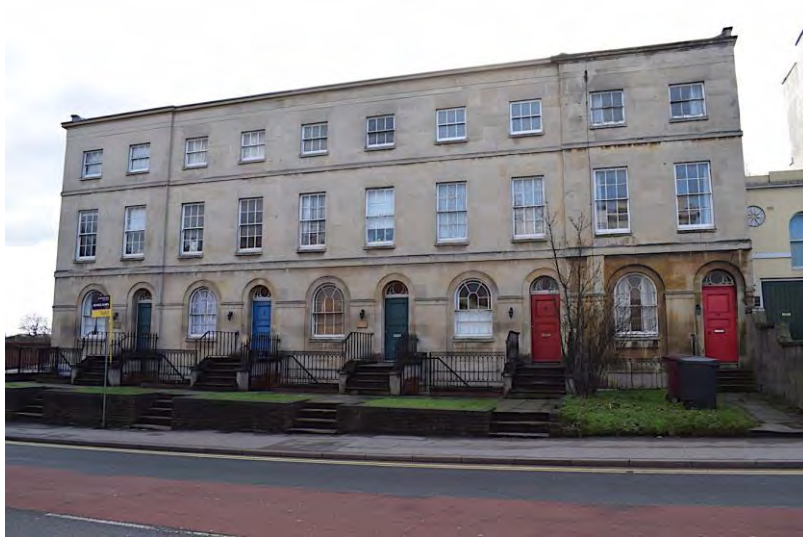
Figure 6.1.12 Blenheim Terrace, Bath stone terrace, 97-105 Castle Street (David Neale)

The Grade II early 19th century Bath stone Blenheim Terrace, at nos. 97-105 Castle Street, is impressive in scale and its classic detailing. It is one of only two extant Bath stone properties remaining within the conservation area. No.105 is regrettably in a poor state of repair.

- 97 to 105 Castle Street (S. side), Grade II. Early 19th century terrace of five houses, 3 storeys and basement. Bath stone, arched openings to ground floor, string courses and parapet. Steps to principal storey. Original cast iron railings to areas. Houses to end of terrace set slightly forward. 1321959.
- 107 Castle Street (S. side), Grade II. Circa 1800 Georgian stucco house, 3 storeys and semi basement, steps to entrance. Principal floor, arched windows and rusticated stucco, four ionic pilasters and moulded entablature to upper floors, slate roof. Poor forecourt as parking. 1113421.
- 109 Castle Street (S. side), Grade II. Circa 1800 Georgian stucco house, 2 storeys plus semi basement and attic. Steps to entrance. Rusticated stucco to basement and entrance storey. Tripartite windows. Bracketed eaves and slate roof. Poor forecourt as parking. 1113422.

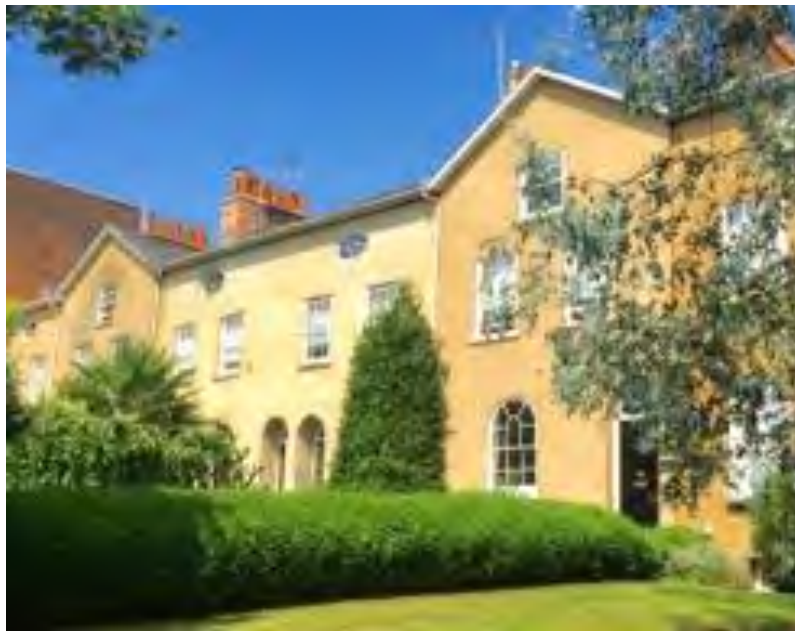
Figure 6.1.13 Bath stone coloured stuccoed Regency style terrace, 134-144 Castle Hill (Karen Rowland)

Underlying red brick is notable only occasionally, largely seen on upper floors and to the side and rear of the properties. Regrettably, at nos. 134-144, the original Bath stone façade was removed in the latter part of the 20th century and replaced by Bath stone-coloured stucco although it is still a very attractive terrace with Regency detailing.

The attractive Grade II Regency detailed terrace at 134-144 Castle Hill is set back from the road in well-tended deep gardens. Its Bath stone coloured stucco façade is a replacement of its original Bath stone façade which was removed in the 1960s.

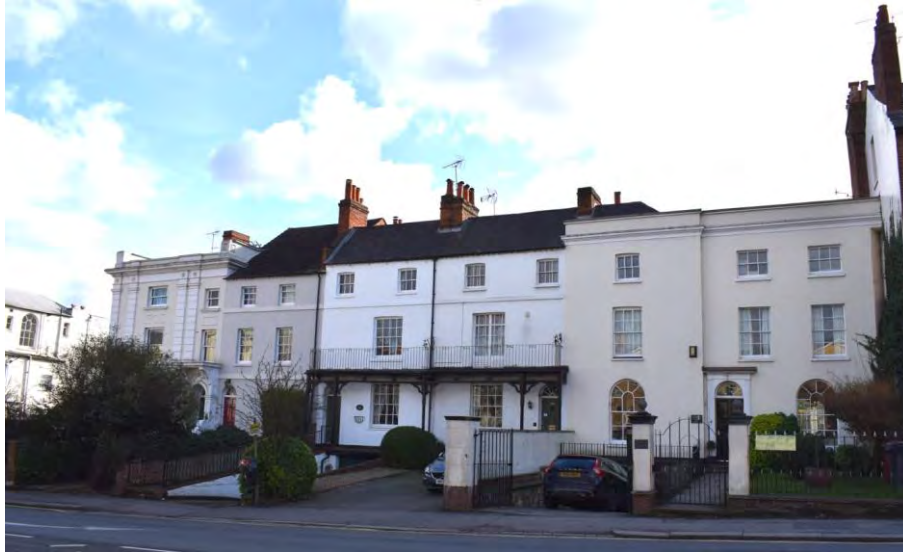
Figure 6.1.14 Attractive diverse terrace of Georgian properties at 113-121 Castle Street (David Neale)

The fine grouping of houses at nos. 113-121 (all Grade II) create a pleasing collection on the south side of the street. The terrace is attractive because of the houses' Georgian architectural variety, despite dropped kerbs for parking along most of the fronts. No. 113 forms a particularly striking end with its rusticated paired pilasters, topped with wreaths.

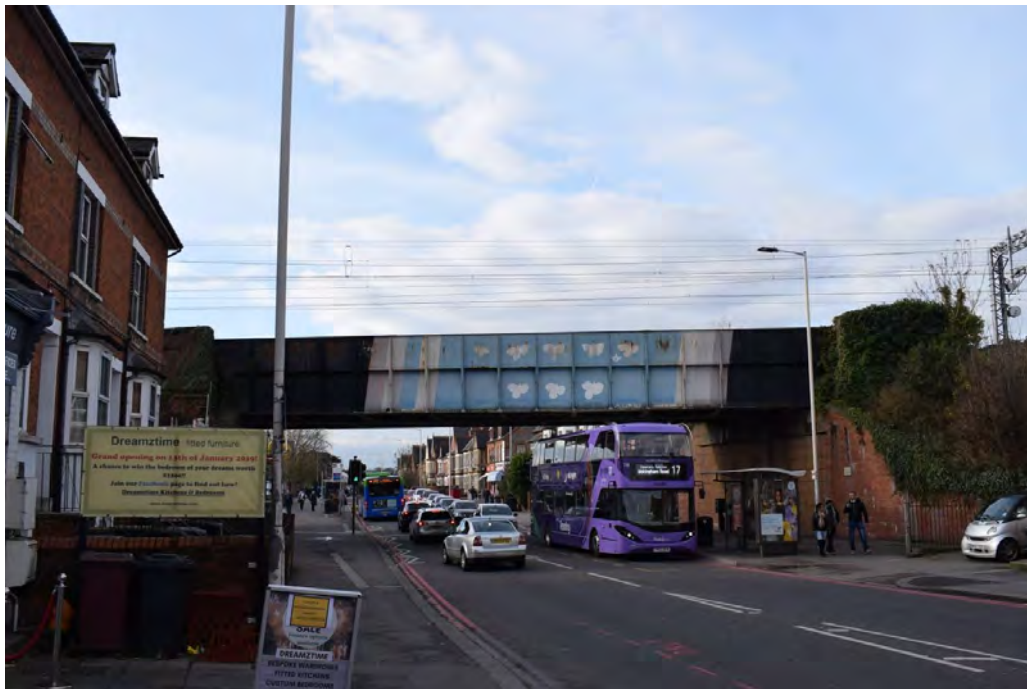
Figure 6.2.2 Reading West railway bridge, facing west along the Oxford Road, the iron bridge replaced an original brick design (David Neale)

- The poor decorative condition of the railway bridge over the Oxford Road

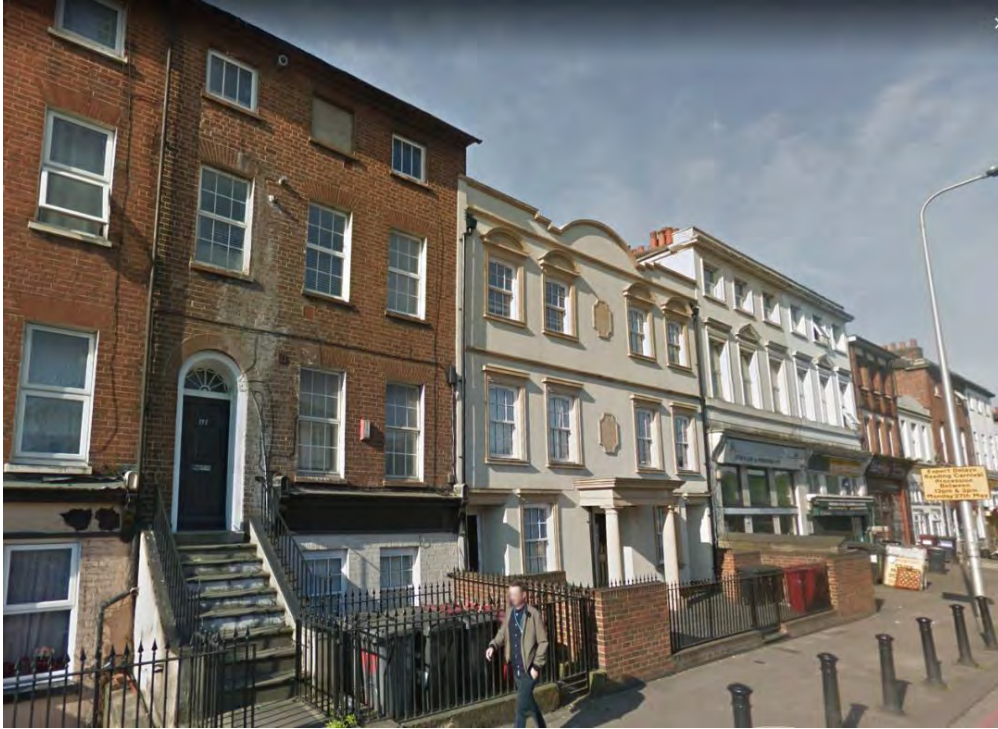
Figure 6.2.3 Oxford Road between Russell Street and Prospect Street - poor condition Georgian terraces, acceptable modern pastiche of pre-existing elements, varied shop façades and poor public realm (Google Maps)

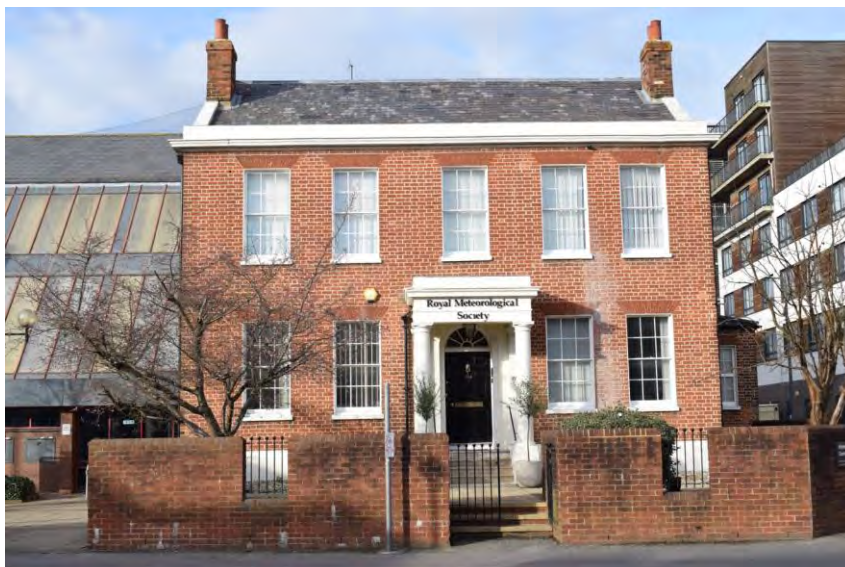
Figure 6.2.6 National Meteorological Society at 104 Oxford Road, a detached Georgian house with porticoed front porch surrounded by unsympathetic modern build (David Neale)

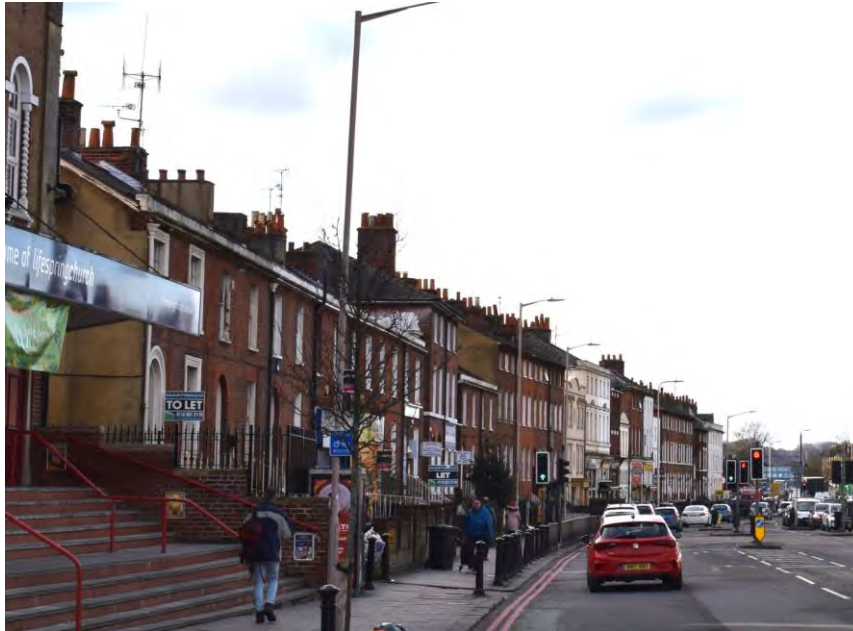
Most of the early residential terraces are in poor to moderate condition, with several converted to shops at ground floor level. The Georgian terraces are largely of red brick, except for the impressive stuccoed villas at nos. 197-203. Fortunately, a majority of the listed terraces still retain original windows, doors and detailing although there are some exceptions where enforcement has failed to catch uPVC replacement window in the listed terraces. Some of the original brick walls in front of these properties, notably at nos. 149-153, need repair and re-pointing.

Figure 6.2.7 Listed Georgian terraces along Oxford Road, in poor repair, lost behind cluttered street furniture and busy road traffic (David Neale)

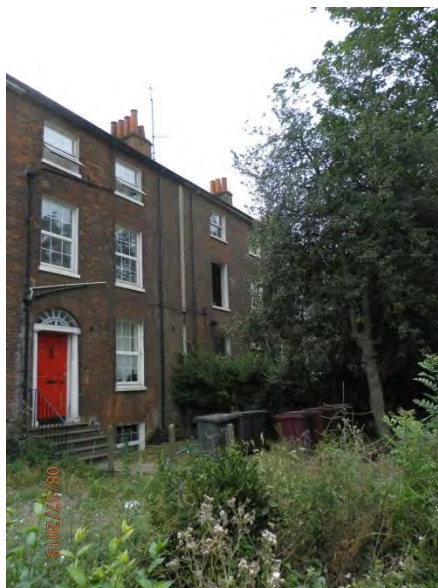
Prospect Terrace is a fine, Grade II Georgian terrace set back from the Oxford Road largely in poor condition and negatively impacted by the petrol station opposite and the busy road.

Figure 6.2.8 237 and 239 Oxford Road, part of Prospect Terrace, 237-247 Oxford Road/2 Lorne Street (Reading Borough Council)

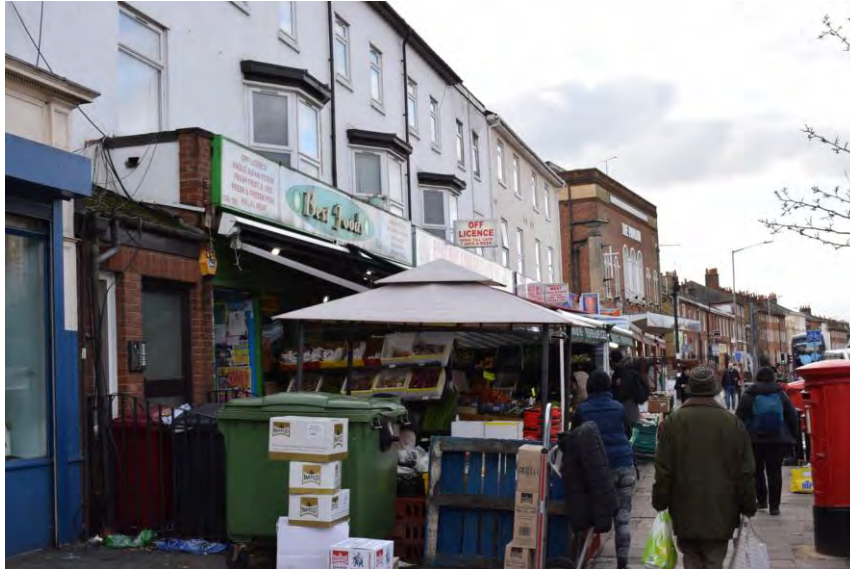
Figure 6.2.9 Proudly diverse grocers and shops do business amid clutter and poor signage which mask the original early 19th century structures on Oxford Road between Russell Street and Waylen Street (David Neale)

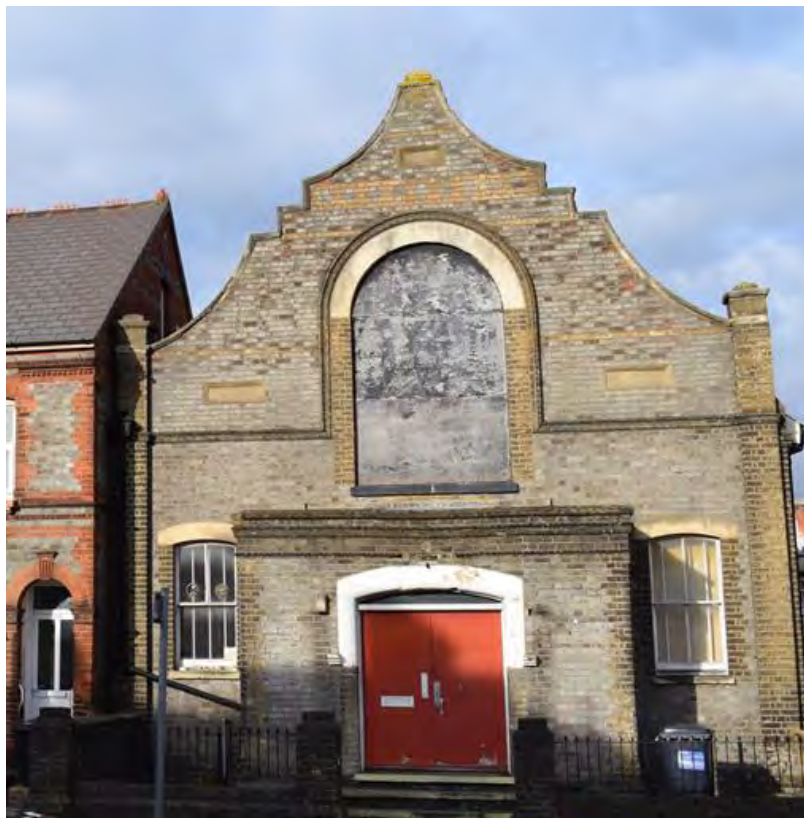
Figure 6.2.13 Bridge Hall, originally built for the Reading Open Brethren Group, in poor repair (David Neale)

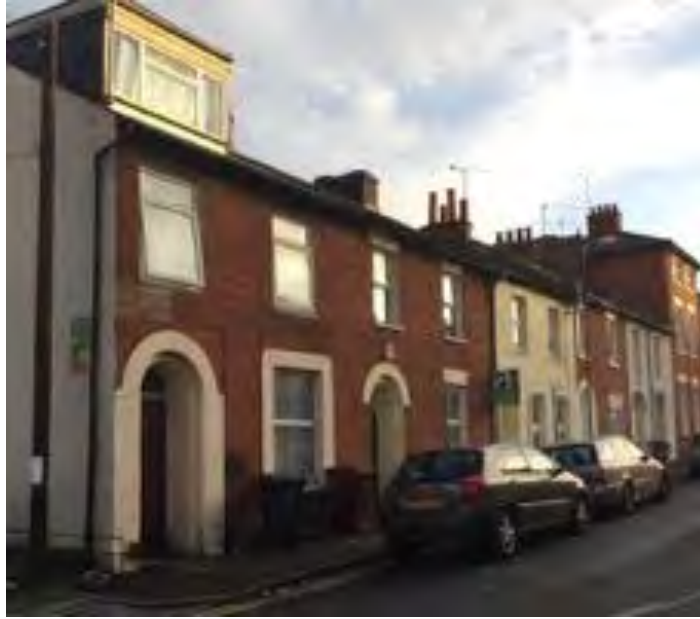
Figure 6.2.15 1-9 Prospect Street, a rare modest Georgian artisan terrace with the over- bearing modern dormer window at no. 1 (Karen Rowland)

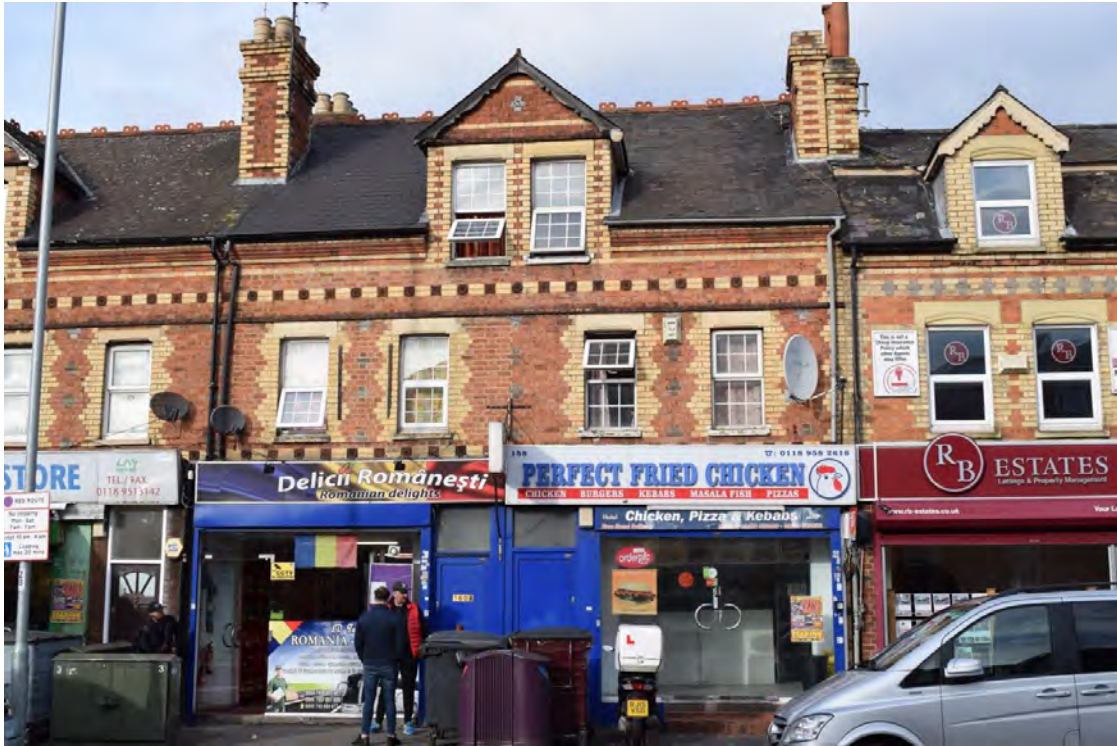
Figure 6.2.18 Long retail terrace, 152-180 Oxford Road, stunning polychrome and largely intact, although incompatible signage and store fronts detract from its appearance (David Neale)

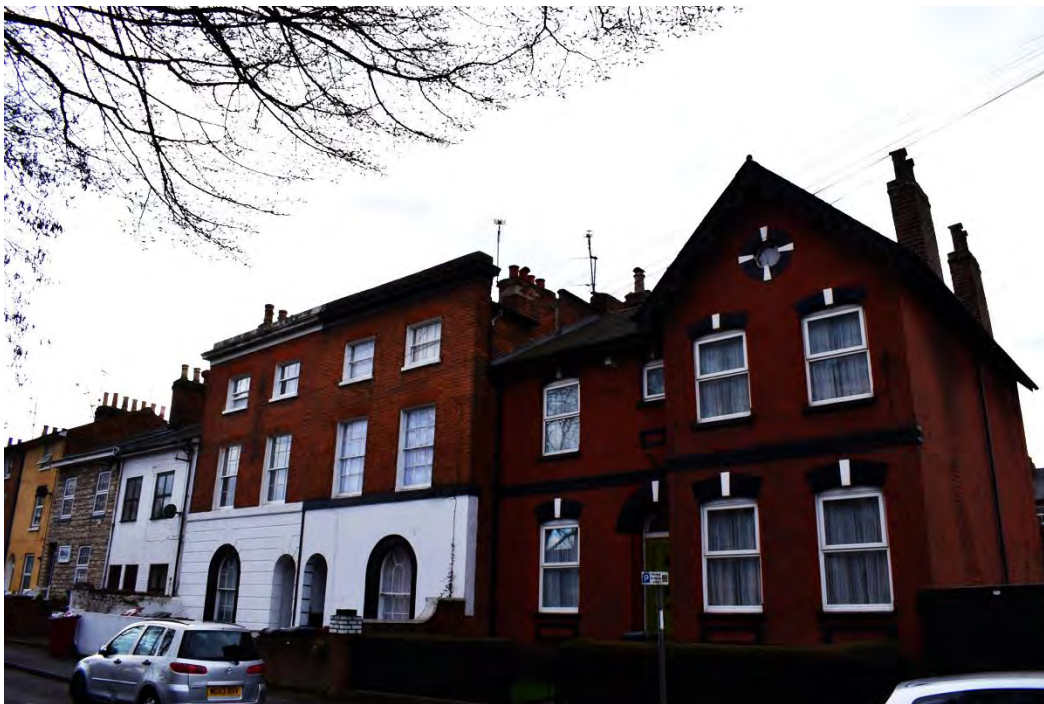
Figure 6.3.4 2, 4 and 4A (listed Georgian semi-detached terrace) Howard Street showing the rustication on 4A (David Neale)

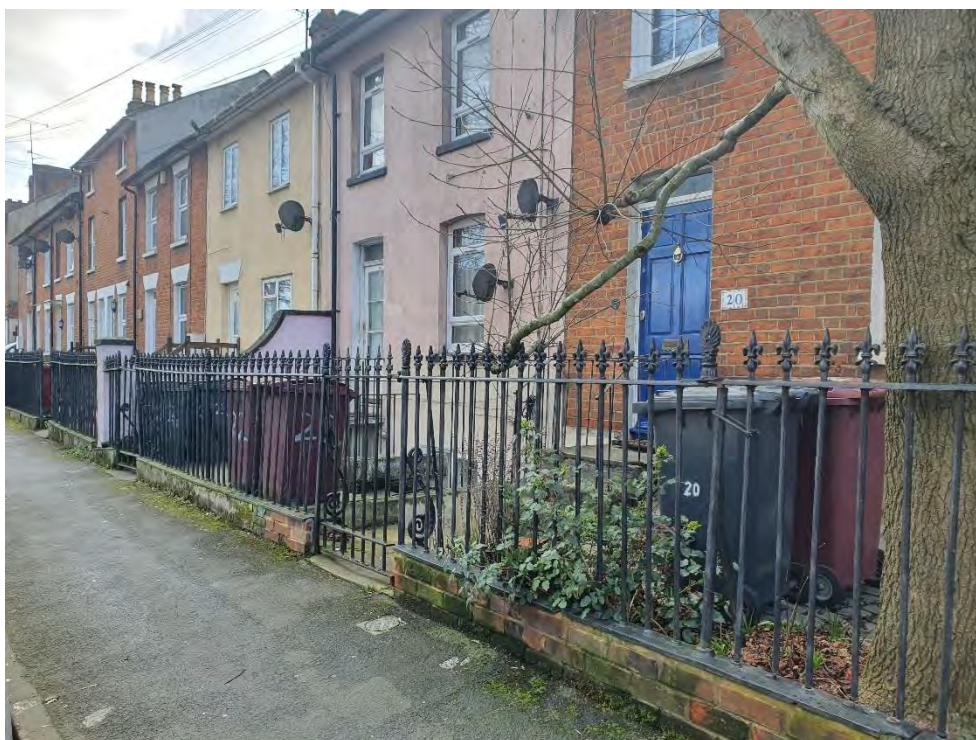
Figure 6.3.5 Original iron railings at 16-22 Howard Street and the curved stucco dividing wall at no. 22 (Mark Worringham)

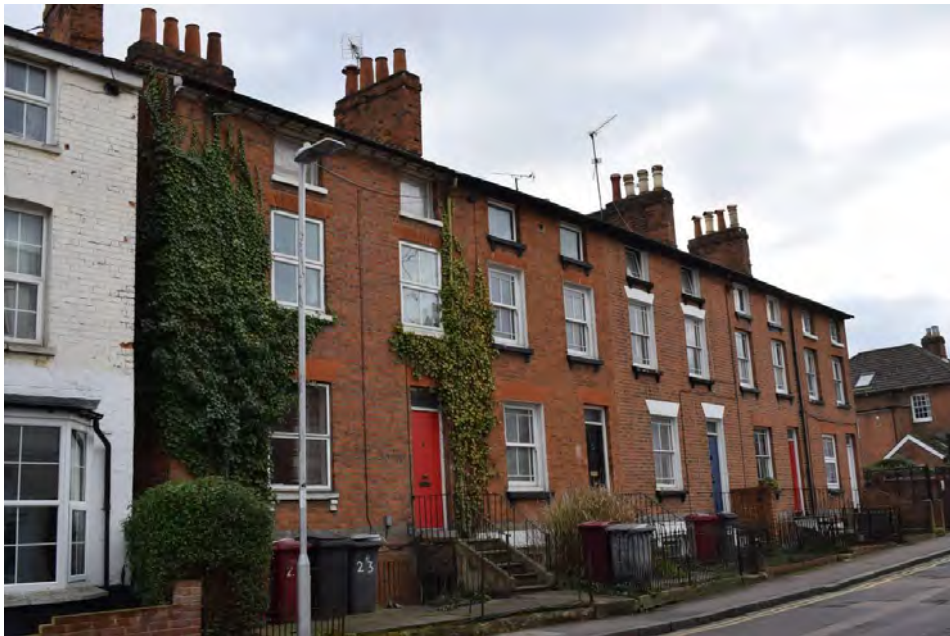
Figure 6.3.13 23- 31 Baker Street, Alexandra Terrace, c.1850, red brick terrace, overall well-preserved with majority of original windows and doors intact (David Neale)

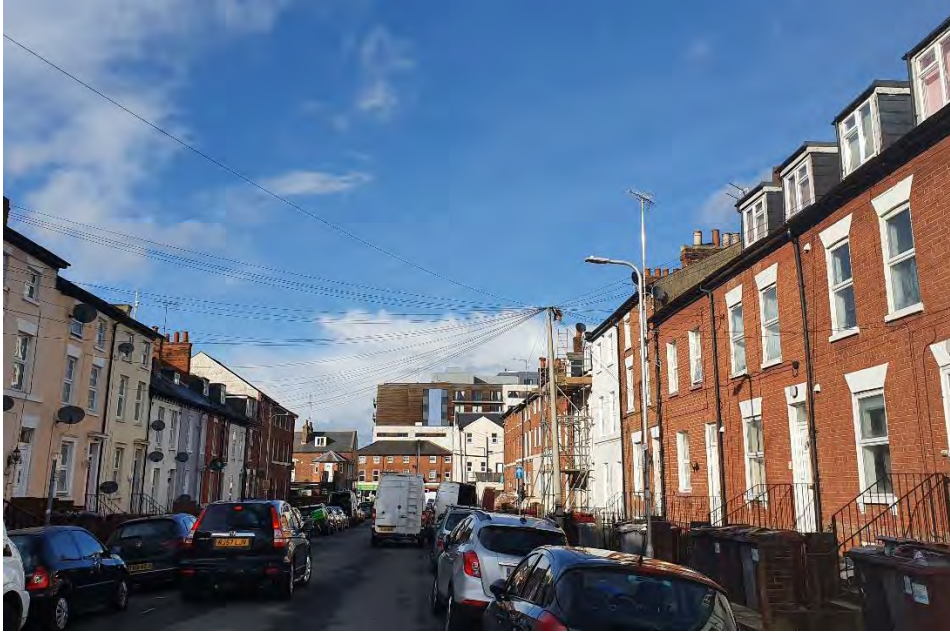
Figure 6.3.17 The conditions of terraced housing looking north along Zinzan Street with poor quality modern dormers, overhead wires, excessive bins and satellite dishes. (Mark Worringham)

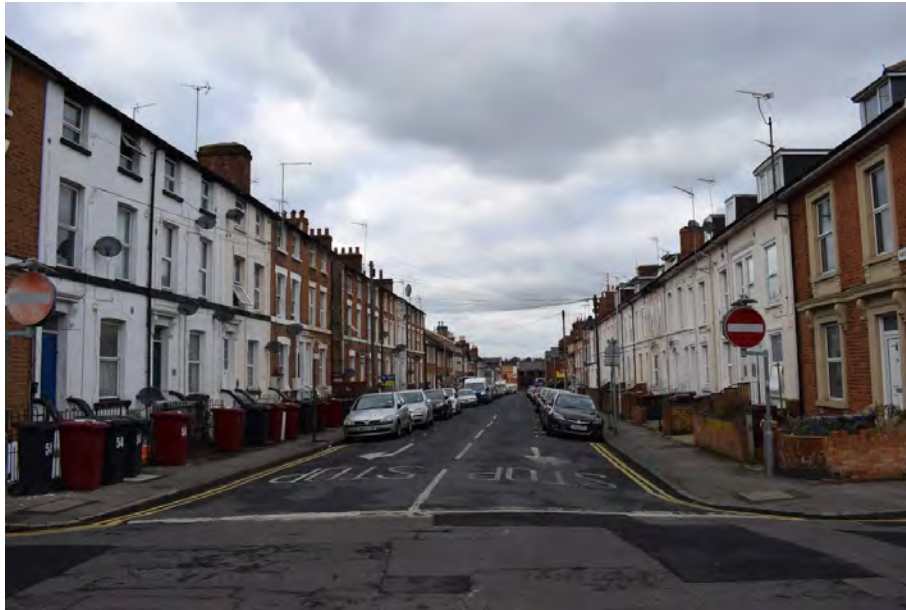
Figure 6.3.18 Looking north along Waylen Street with its overall poor conditions. The **street's earliest** houses, nos. 43-61, are on the right c.1840 (Karen Rowland)

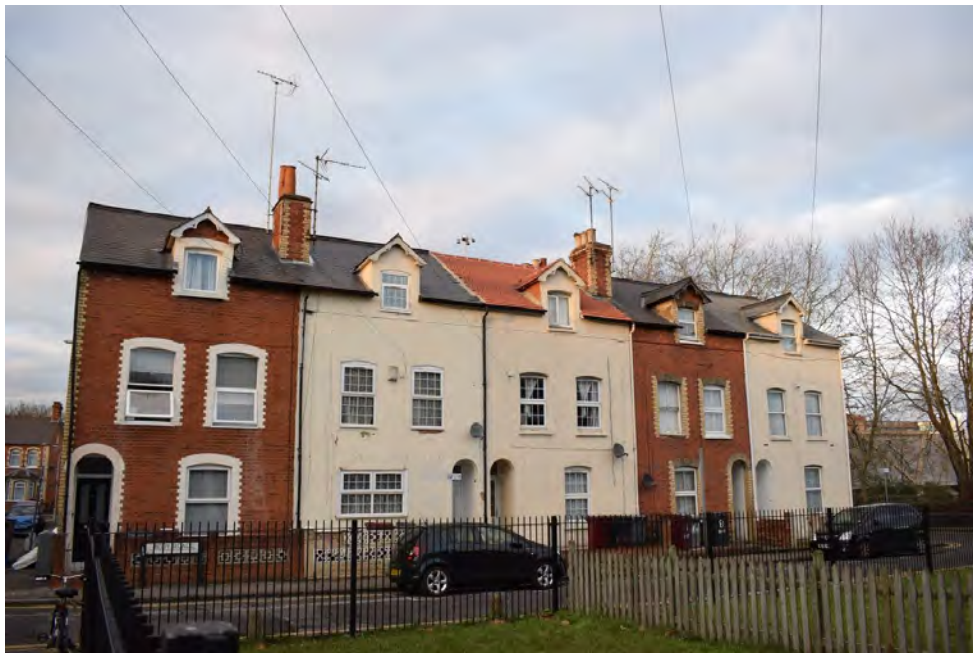
Figure 6.3.21 6-12 Body Road, the new red tile roof was installed in 2017 during the time protection of a conservation area did not apply (David Neale)

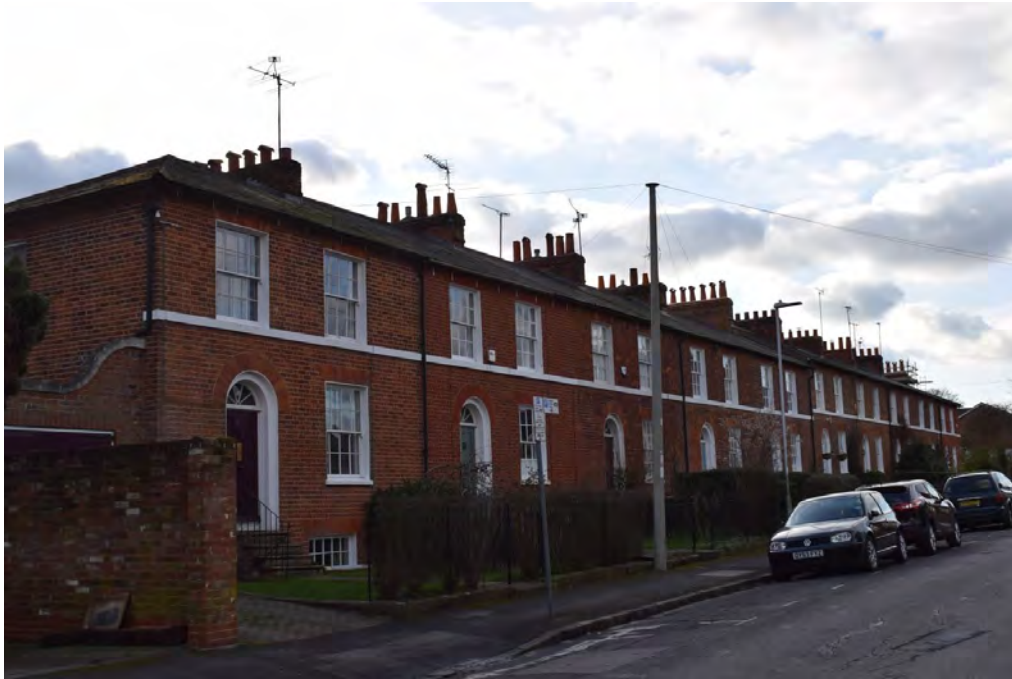
Figure 6.4.3 The listed Georgian terraced houses from 61-79 Baker Street, complete with original doors, fanlights and windows (Mark Worringham)
