# Extended Phase 1 Habitat Survey Report

55 Vastern Road, Reading, RG1 8BU

April 2018

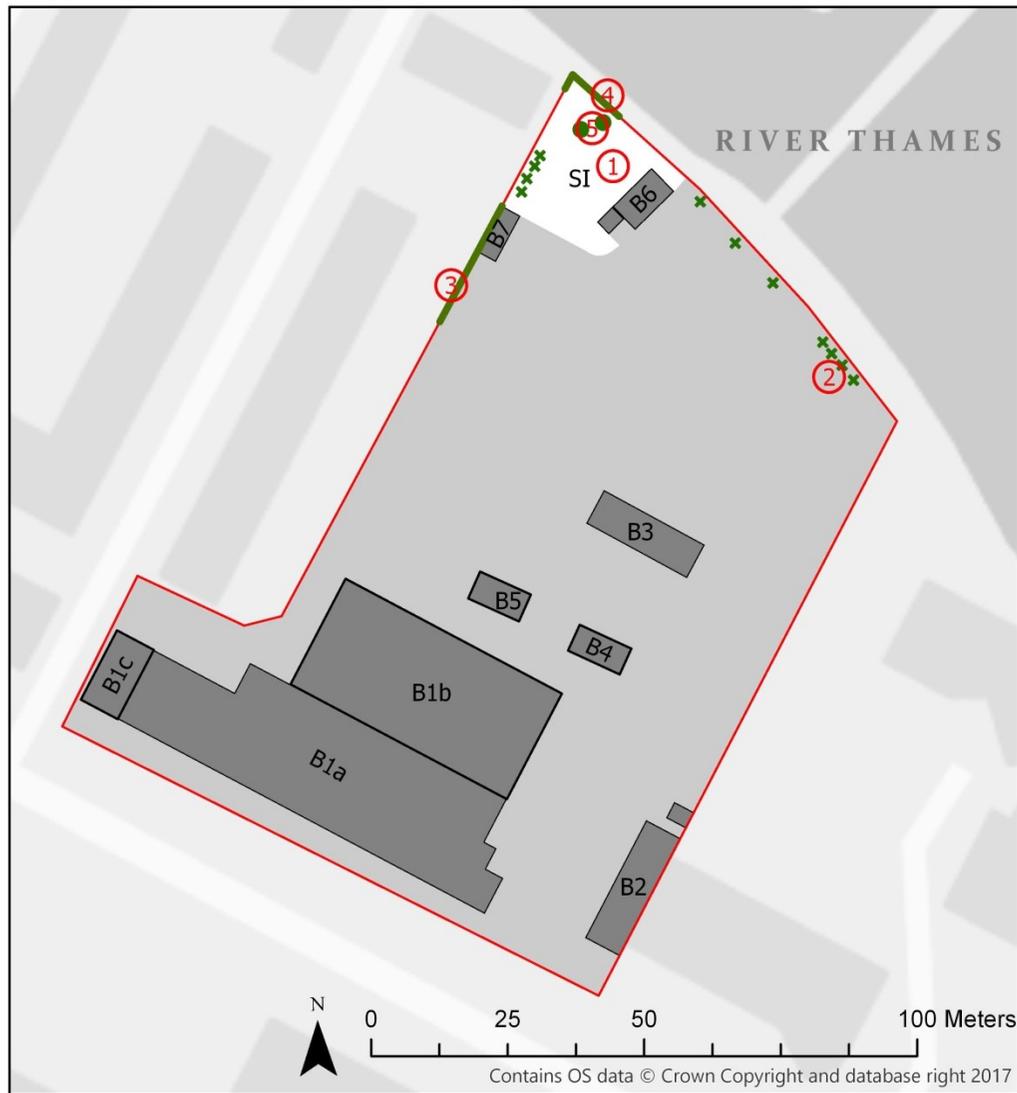
Figure 2: Phase 1 map

- 4.2.1 The site is dominated by building and hard-standing. The following habitat types are present on site:
- poor semi-improved grassland
  - scattered scrub
  - intact species poor hedgerow
  - individual trees
  - building
  - hardstanding

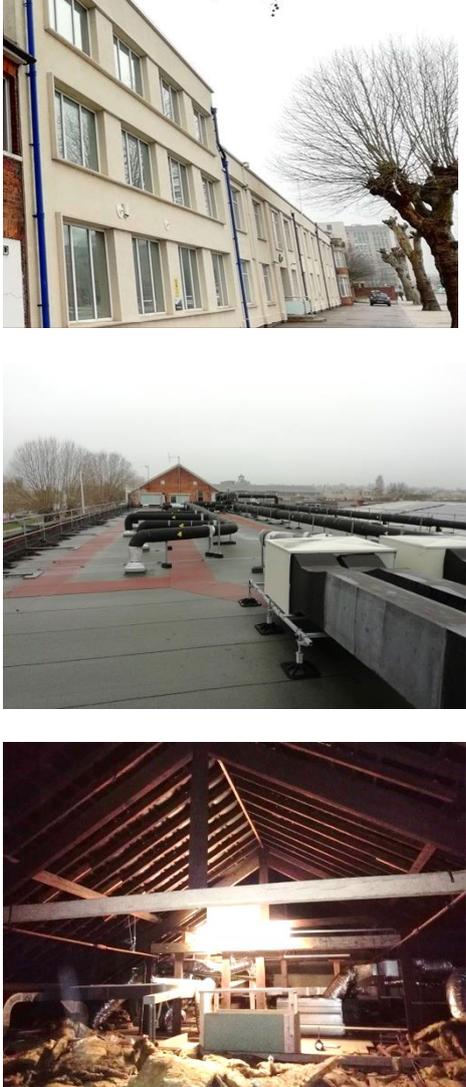
Description	Photo
B1a	<p>A large structure that was up until May 2017 used as offices. The exterior of the structure is well-sealed with no obvious access/roosting habitat for bats (see image right top). The majority of the roof is flat and felt was replaced in 2011 (see image middle right). A single pitched roof section is present in the wester section covered in corrugated metal sheeting. Roof coverings are in good condition with no obvious access for bats.</p> <p>A single loft void is present beneath the pitched section of roof. The void is well-sealed with no obvious access for bats. The eastern section is cluttered with water tanks and ducting (see image bottom right).</p> <p>The building does not provide suitable habitat to support roosting bats.</p>

<p>The 'Photo' column contains three images. The top image shows the exterior of a multi-story office building with a light-colored facade and many windows. The middle image shows a flat roof area with several large white water tanks and various pipes and ducting. The bottom image shows the interior of a pitched roof structure with exposed wooden rafters and beams, illuminated by a bright light source.</p>

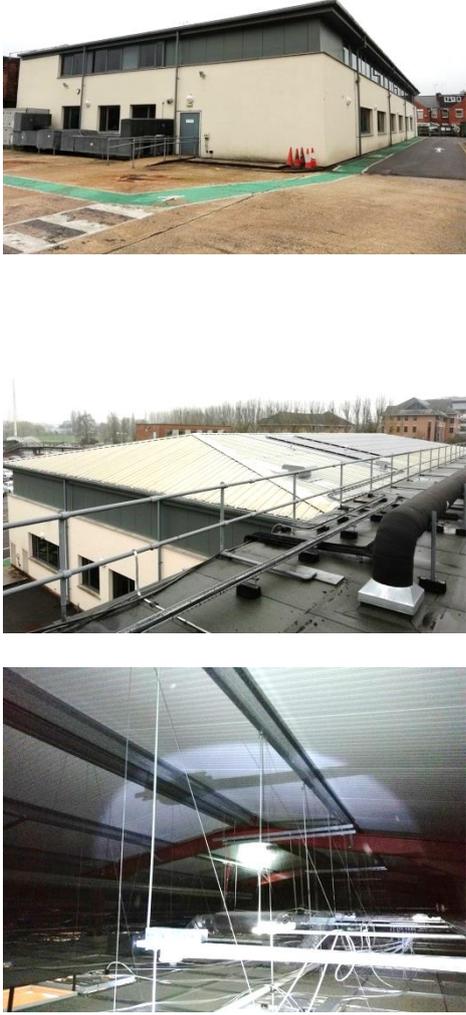
Description	Photo
B1b	<p>A large modern structure that was used as offices up until May 2017 (see image top right). The shallow pitched roof is covered in corrugated metal sheeting that is in good condition (see image middle right). The exterior of the structure is well-sealed with no obvious access/roosting habitat for bats.</p> <p>A single well-sealed loft void is present above a suspended ceiling. The suspended wires promote a cluttered void (see image bottom right).</p> <p>The structure does not provide suitable habitat to support roosting bats.</p>

<p>The top photograph shows the exterior of a modern, single-story office building with a light-colored facade and a dark, shallow-pitched roof. The building is situated on a paved area with some green-painted sections. The middle photograph shows a close-up of the roof, which is covered in corrugated metal sheeting. A large black pipe is visible on the roof. The bottom photograph shows the interior of the building, focusing on a cluttered loft void above a suspended ceiling. Numerous wires and cables are visible, creating a complex network of lines.</p>

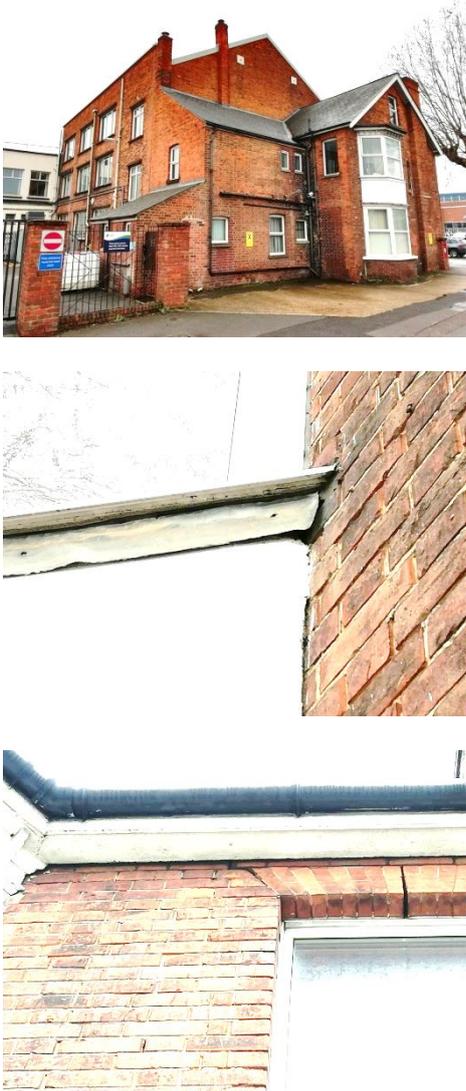
Description	Photo
B1c	<p>A brick section of building with a pitched roof covered in close fitting slates that was used as offices up until May 2017 (see image top right). The walls and roof are well-sealed. A single inaccessible shallow loft void (less than 1m height) is present. Street lighting promotes high light levels around the exterior of the building.</p> <p>A gap is present beneath lifted lead flashing (see Image middle right) with an additional gap between timber soffit and wall (see Image bottom right).</p> <p>No evidence of roosting bats was recorded when closely viewed closely.</p>

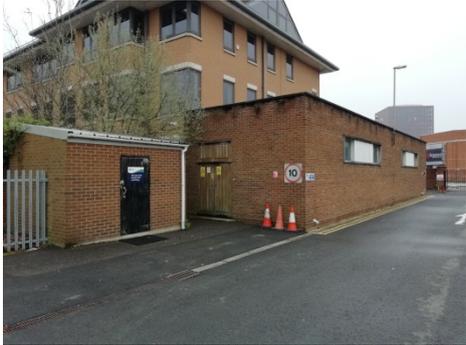
B2	<p>A flat roofed brick building used as an electricity substation (see image right). The roof and walls are well-sealed with no obvious access for bats. A separate small substation is present to the north which is equally well-sealed with a shallow sloping roof.</p> <p>Access was unavailable to the interior of these structures.</p> <p>The exterior of the structures does not provide suitable habitat to support roosting bats.</p>

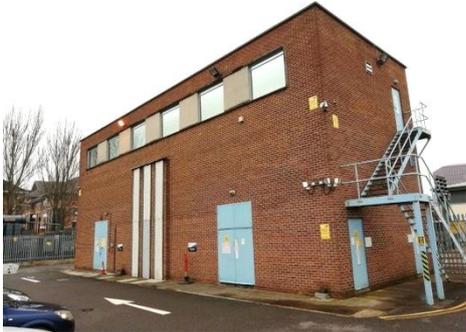
Description	Photo
B3	<p>A flat roofed brick building used as an electricity substation (see image right). The roof and walls are well-sealed with no obvious access for bats.</p> <p>Access was unavailable to the interior of the structure.</p> <p>The exterior of the structure does not provide suitable habitat to support roosting bats.</p>

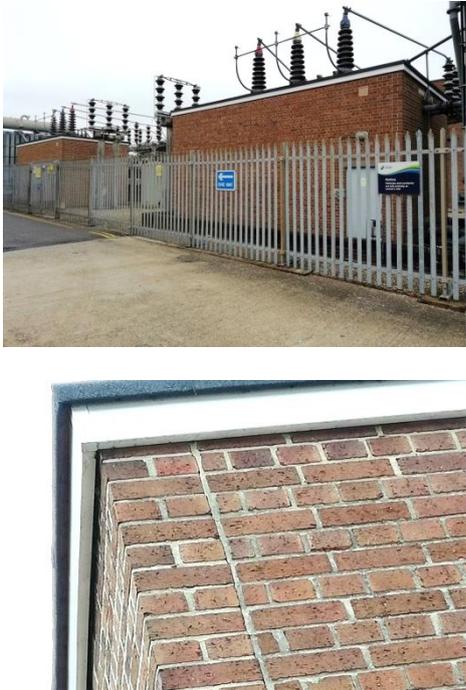
B4	<p>A flat roofed brick building used as an electricity substation (see image top right). The roof and walls are well-sealed with no obvious access for bats.</p> <p>Access was unavailable to the interior of the structure.</p> <p>A gap is present between plastic fascia and brick walls on the southeast and northwest elevations that was heavily cobwebbed (see image bottom right).</p>

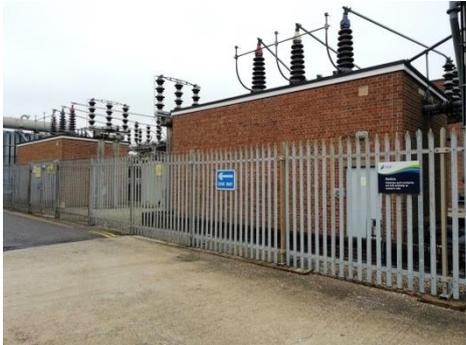
B5	<p>A flat roofed brick building used as an electricity substation (see image right). The roof and walls are well-sealed with no obvious access for bats.</p> <p>Access was unavailable to the interior of the structure.</p>

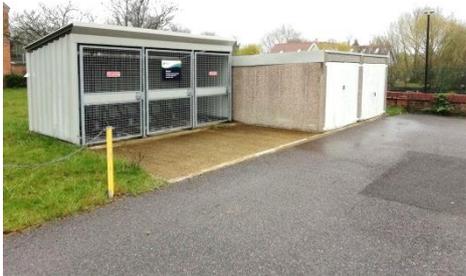
Description	Photo
B6	<p>A double concrete garage with flat roof and a metal bicycle shed (see Image right).</p> <p>The structures do not provide suitable bat roosting habitat.</p>

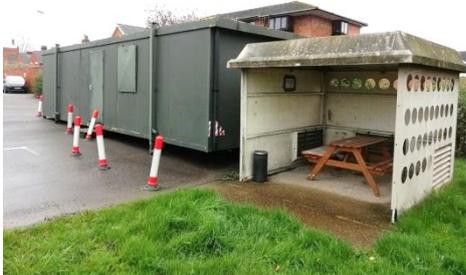
B7	<p>A temporary prefabricated structure previously used as a workshop with open fronted smoking room (see image right).</p> <p>The structure does not provide suitable bat roosting habitat.</p>
