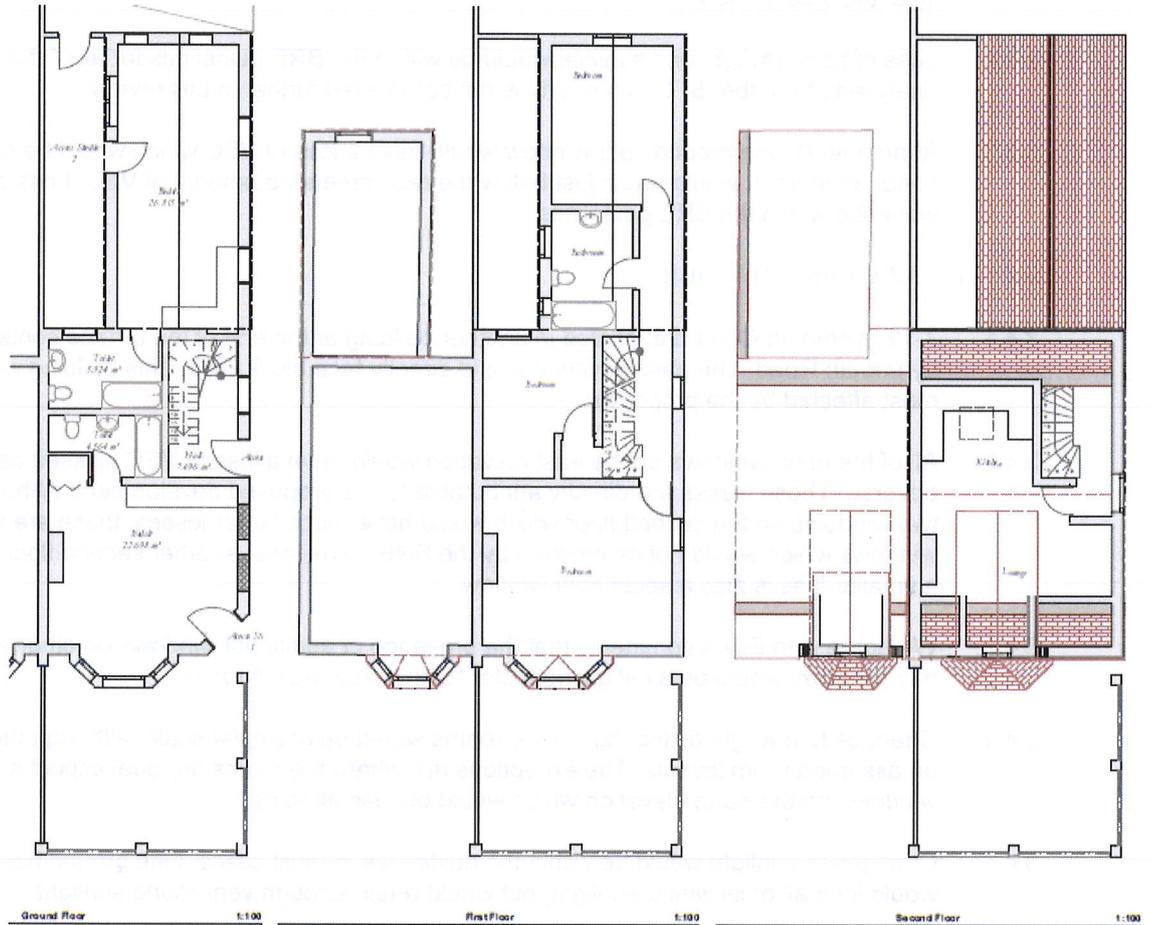
3.5.3 These room layouts, and the layouts in the existing plan submitted in the same application, suggest that the affected windows on the ground and first floors are either secondary windows with the main windows located on other elevations, or light stairwells. It therefore appears likely that none of the affected windows are covered by the BRE guidelines.

Figure 3 51 Vastern Road approved floor plans, from drawing PDM-06 Rev C by The Keen Partnership.

- 3.5.2 Valuation Office Agency records indicate that there is currently a flat on the first floor. At the time of writing there was no record of a ground floor flat and online streetview imagery shows a café on the ground floor. The recent planning history for the property includes some plans: a permitted development application reference 190692 for conversion of the upper floors to two flats and a planning application reference 191165 for conversion of the ground floor to two bedsits. The proposed room layouts for the latter are shown in Figure 3 below. The room layouts for the upper floors differ from those in the earlier permitted development application.

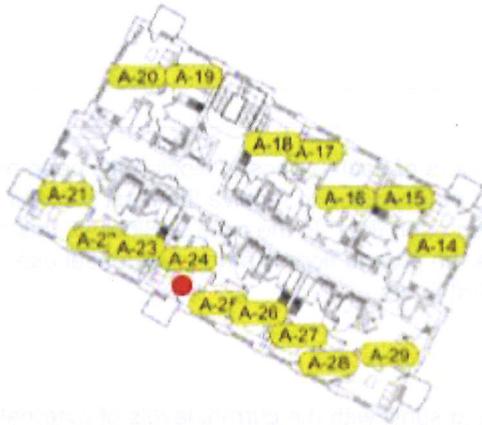
- 4.2.2 Living room A-24 on the first floor, see Figure 4 below, would have an ADF of 1.4%, just below the recommended minimum for living rooms. This is a large room facing south west with a balcony located above the window. This would normally be less of an issue as it is not unusual for a few rooms in a development to receive less daylight, the ADF would be only just below the guidelines and the balcony design gives the compensatory benefit of private amenity space. However, the concern is that at the moment the area opposite, Vastern retail park, is low rise, so the only limit on the daylight received by this room is the design of the development itself. This is anticipated to change. The design and access statement notes that there is an emerging development on the Vastern retail park site on the other side of Vastern Road. The developers of that site will also wish to make best use of their site and the levels of obstruction can therefore be expected to increase significantly in the future. If a room cannot receive enough daylight when it has very little external obstruction, it is likely to become significantly worse in the future. Windows with balconies above them can be expected to lose a larger proportion of their daylight if obstruction levels opposite them increase. This room is therefore vulnerable to a substantial future loss of light with its present design.

Figure 4 Block A first floor, ADF failure marked

- 4.2.3 The ground floor room below, which does not have a balcony rail in front of it, would receive just enough daylight with current levels of obstruction. The equivalent rooms on the upper floors would be expected to have similar results to the first floor. Whether they would be similarly affected by a development on the Vastern retail park site would depend on the height and proximity of the proposed buildings. Subject to other factors involved in site design, these rooms would benefit from some additional glazing which is not underneath a balcony to protect them from a disproportionate loss of daylight when Vastern retail park is redeveloped.

- 6.1.10 Some south facing windows in Block A fall only marginally short of the recommended amount of daylight, but their design renders them vulnerable to substantial future loss of light from an emerging development for Vastern retail park. Where an increase in future obstruction is likely, the design could protect the future occupants by not rendering their windows dependent on an area of the sky which is likely to be blocked, for example by providing additional glazing which is not located underneath a balcony.
- 6.1.11 Living room windows facing within 90° of due south generally receive the recommended amount of sunlight. The exception is ground floor windows in block EFG, which are heavily obstructed by other blocks in the development.
- 6.1.12 All of the amenity areas in the proposed development would receive the recommended amount of direct sunlight.

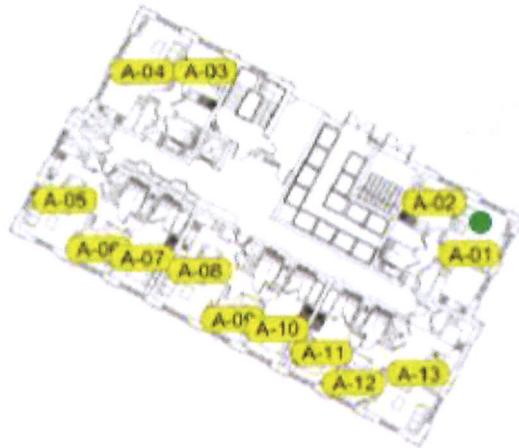
- 4.2.5 Living room A-01 on the ground floor, see Figure 5 below, would receive just below the recommended amount of sunlight. It faces just within 90° of east and would have Block BC to the east of it. The equivalent rooms on upper floors would receive enough sunlight with current levels of obstruction. This individual result is probably reasonable given the room's orientation and position in the block.

Figure 5 Block A ground floor, sunlight failure marked.

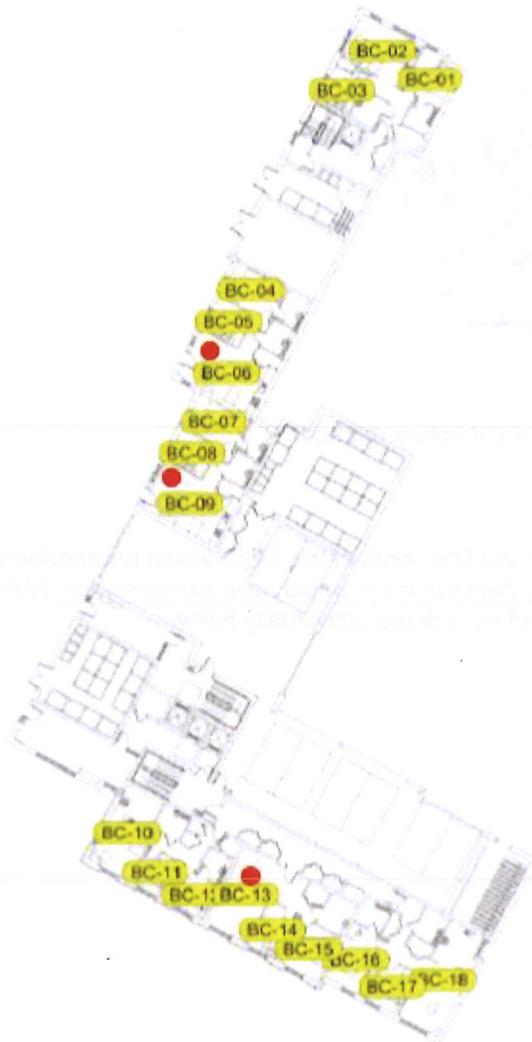
- 4.3.1 Seven living rooms on the ground and first floors of this block would not receive the recommended amount of daylight. Some of them would have extremely low ADFs. They are shown in Figure 6 and Figure 7 and considered individually below.

Figure 6 Block BC ground floor, ADF failures marked.

- 4.3.2 Living room BC-06 on the ground floor faces north west. It would have an extremely low ADF of 0.3%, where the recommended minimum for living rooms is 1.5%. This room would be very gloomy and need supplementary electric lighting almost all the time. Daylight provision to this room should be improved if at all possible. The equivalent room on the first floor would be better but would still fall well short at 1.0%. The main windows face the terrace of two storey houses on Lynmouth Road, and would therefore not be particularly obstructed externally; their poor levels of daylighting are therefore a consequence of their own design and the equivalent rooms on upper floors may well have the same issue. In particular, the ground floor room has a much narrower main window than the first floor room and has the potential for improvement subject to other site design factors. They both appear to have the potential for increased window area in their side elevation.

- 4.3.3 Living room BC-09, also on the ground floor and facing north-west, has a low ADF of 0.9%. This room is large for its window area. There appears to be some limited potential to increase window area but it is unlikely to be possible to bring this room up to a pass without loss of room area.

- 4.3.4 Living rooms BC-13 on the ground floor and BC-39 on the first floor face south west. BC-13 would have an ADF just below the recommended minimum for living rooms at 1.4%. BC-39 would be a lot lower at 0.8%. It has a large floor area for its window size, but it does have the compensatory benefit of private amenity space. These rooms are potentially vulnerable to loss of daylight due to the future development of Vastern retail park, but less so than the equivalent rooms under balconies in Block A as the retail park site is slightly to one side and block BC faces Station Shopping Park.

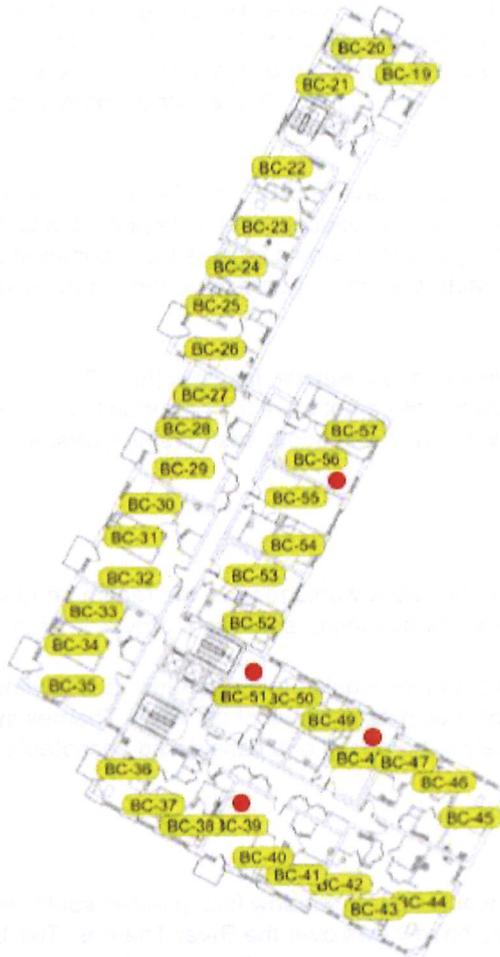
Figure 7 Block BC first floor, ADF failures marked

- 4.3.5 Living room BC-48 faces north east. It is important that north facing rooms are well lit as they will not have the benefit of sunlight in that position. The room has an ADF of 1.4%, just below the recommended minimum for living rooms. It does not have an overhead balcony limiting its overhead daylight, and so it does not have the compensatory benefit of private amenity space.

- 4.3.7 Room BC-56 would face south east. It would have an ADF of 1.2%, below the recommended value for living rooms. This room would have a reduced level of daylight, but without the compensatory benefit of private amenity space. It would receive the recommended amount of sunlight. Subject to other site design factors, there appears to be the potential to increase the size of this window.

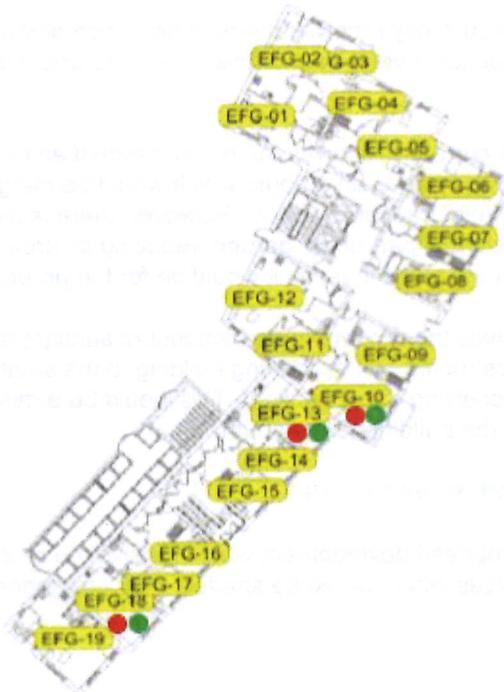
- 4.5.2 Three ground floor rooms in this block, marked in Figure 8 below, would not receive enough of either daylight or sunlight. The individual rooms are discussed below.

Figure 8 Block EFG ground floor, ADF (red) and sunlight (green) failures marked.

- 4.5.3 Living room EFG-10 is dual aspect. It has a main window facing south east which is located underneath a balcony and a secondary window facing south west. It would have an ADF of 1.4%, just below the recommended amount for living rooms. It would receive the recommended amount of year round sunlight, but would receive just below the recommended amount of winter sunlight. The sunlight would be difficult to change due to the other buildings in the development presenting an obstruction to the south and east, and year round sunlight is more important. However, subject to other site design factors, the ADF could potentially be improved by increasing the glazing area.

- 4.5.4 Living room EFG-13 faces south east. It would be extremely poorly daylit. It is a large room for the size of its window and it would have an ADF of 0.3% against a recommended minimum for living rooms of 1.5%. It would also receive almost no sunlight, 3% of annual probable sunlight hours against a recommended minimum of 25%, and 2% of winter sunlight hours against a recommended minimum of 5%. It would be a very gloomy room which would need supplementary lighting almost all of the time. On higher floors, the rooms in the same position don't have the same problem as there is another window to the rear of the room. Daylight to this room should be improved if at all possible. It would be difficult to improve the amount of sunlight it receives as sunlight is obstructed by the other blocks of the development. This makes reasonable daylight provision even more important.

- 4.5.5 Living room EFG-18 also faces south east. It would have an ADF of 0.6% against a recommended minimum of 1.5% for living rooms. The room is large for its window size. There appears to be some limited potential for increased window area, but it is probably not possible to bring the daylight up to a pass without losing floor area or making very large changes to the design of the scheme. The window would also fall substantially short of the sunlight requirement, receiving 5% of APSH against a recommended minimum of 25%. Winter sunlight would be better, and only slightly below the recommended minimum.

- 4.5.6 We disagree that the very poor results should be accepted as isolated deviations and suggest that the design should be revisited to see if their daylight and sunlight provision can be improved any further. The fact that other homes in the development would be better daylit would not provide any comfort to the people who live in the very poorly lit properties. In particular, 0.3% is an exceptionally low ADF which will provide very poor living conditions.
